West Linton Street Access Audit

Tweeddale Access Panel

November 2022

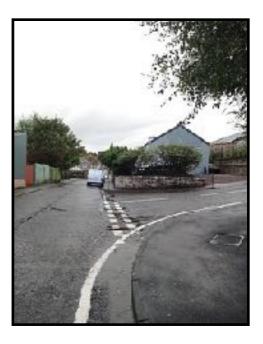
4. SCHOOL BRAE

The junction of Deanfoot Road with School Brae retains an apparently redundant guardrail which should be assessed for removal (picture 4). At the same time, the dropped kerb should be relocated closer to the desire line along the northern pavement of Deanfoot Road. The pavement along the north side of Deanfoot Road is too narrow at 1.1 metres wide especially as the southern footway completely ends abruptly before the Croft Road junction (picture 5). A crossing with dropped kerbs should be installed where the pavement ends at the Smithy to allow people to continue on the footway.

- remove guardrail and improve crossing of School Brae at junction with Deanfoot Road;
- · consider resurfacing Christina Howieson Close with asphalt;
- resurface Broomlee Crescent, especially where pedestrians use the carriageway;

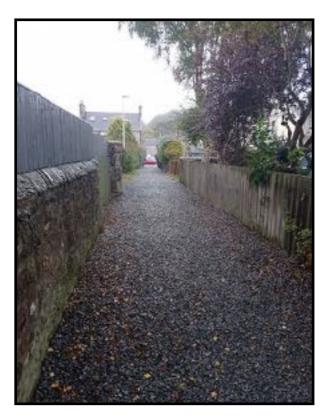
6. CHRISTINA HOWIESON CLOSE

Croft Road itself has no pavements for most of its length, but audit participants felt reasonably safe walking and wheeling as there was little traffic and those vehicles encountered were moving slowly. It is likely that the road would be a hostile place to people with visual impairments. Christina Howieson Close is one of two 'cut-throughs' to Main Street which were reportedly well used, but the surface of loose pebbles is problematic for wheelchair users (picture 6). Consideration should be given to replacing it with an alternative, more stable surface.

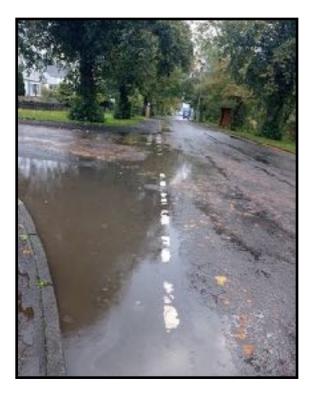
8. STATION ROAD

On the approach to Station Road, the pavement deteriorates in condition. On the day of the audit (the weather was intermittent heavy showers) there was significant ponding at the junction where Broomlee Crescent terminates (picture 8).

- investigate ponding at the junction of Broomlee Crescent/Station Road;
- consider potential sites for more public seating in residential areas, perhaps in discussion with Hanover HA;

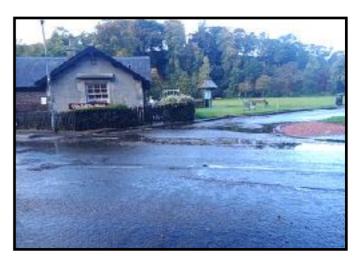
9. LOWER GREEN

There is a wide splay with poor access across Lower Green at the Olde Toll Tea House on the western side of Main Street (picture 9). Ideally this should be 'tightened' with dropped kerbs as appropriate.

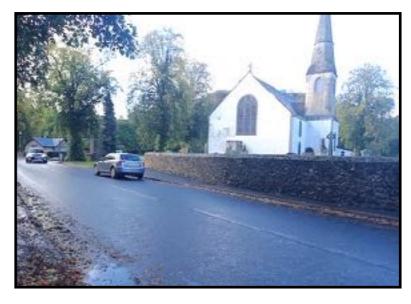
10. MAIN ST AT ST ANDREW'S

The western pavement alongside St Andrew's Church is barely 0.5 metres wide in places and is barely useable by any pedestrian, let alone someone using mobility aids such as a wheelchair, pushchair or sticks (picture 10). This is especially problematic given that the

eastern pavement ends abruptly opposite the churchyard (picture 11). It is recommended that options for significant improvement to this area are investigated, including installation of some form of pedestrian crossing. This could include for example, widening the western pavement adjacent to the church by at least a metre, perhaps accompanied by the introduction of a chicane type arrangement on the carriageway, which would permit vehicles to move in only one direction at a time. This would also have the advantage of ensuring that northbound traffic approaching the village centre moves slowly.

- investigate the possibility of significantly widening the Main Street footway adjacent to St Andrew's Church, perhaps in conjunction with wider carriageway works such as the introduction of a chicane to reduce carriageway space;

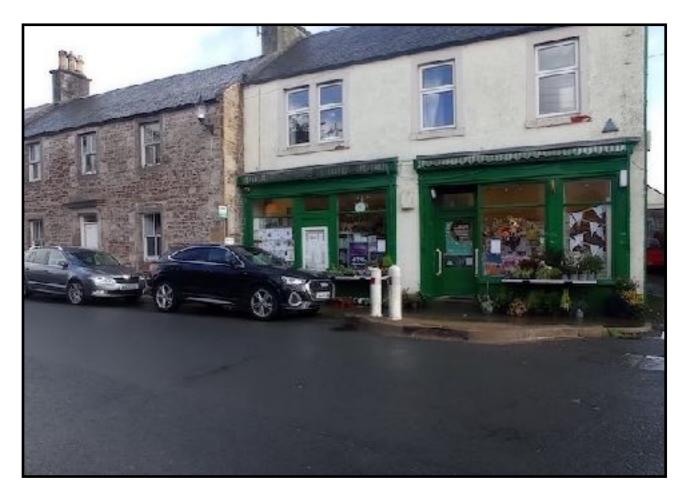
11. POST OFFICE BUS STOP

Suggested locations for some kind of pedestrian crossing on Main Street include at St Andrew's Church (see above), at the Post Office and further north (perhaps at the newsagent or butchers?). The pedestrian route across Main Street at the Post Office (picture 11) is a natural desire line to/from the bus stop, but the sight-lines crossing from west to east are very poor, as traffic approaching from the south is difficult to see owing the bend and on-street parking. The Post Office bus stop would also be improved by significantly extending the raised 'Kassel kerb' northward (removing at least one parking space). It is understood that this stop is busy with schoolchildren at times.

- introduce one or two formal pedestrian crossings on Main Street. This will require more detailed assessment, of both the type of crossing and location but potential sites identified were:

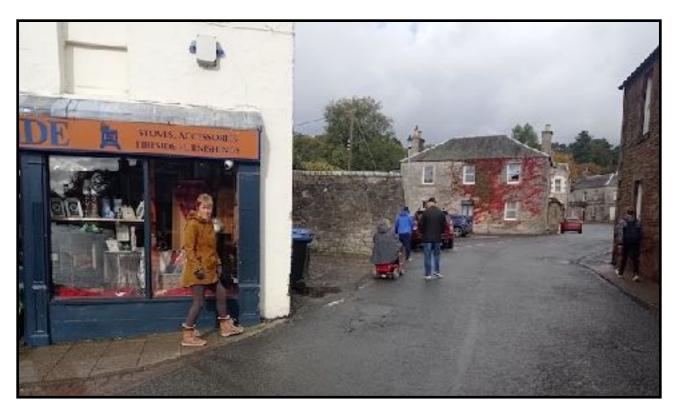
12. MAIN STREET: ABSENT PAVEMENT

Solutions to the fundamental problem of discontinuous pavements (see for example picture 12) and lack of crossings are not obvious unless there is an appetite to consider

significant changes such as exploring the possibility of removing much on-street parking (possibly relocating spaces to the Green where there is spare street capacity) or making Main Street one way. These options could free up space to be re-allocated to pedestrians but it is recognised that there would be significant challenges associated with such options. One participant favoured investigating a type of shared space street design currently in use in Coldingham.

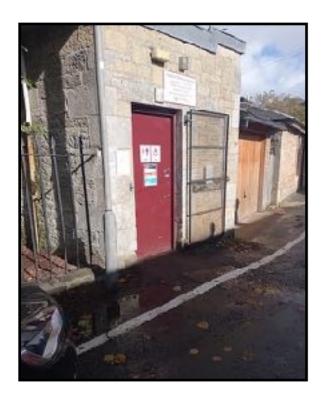
14. PAVEMENT AREA WITH 'A-BOARD'

The very limited pavement space in the village centre was generally clear of 'clutter', but an advertising 'A-Board' was observed at J&R Newsagent on the western pavement (picture 14) and shop goods obstructed the eastern pavement at the Knot. An 'A-board' can also obstruct the A702 pavement at the Gordon Arms. It would be useful to discourage retailers from placing objects on the pavements, or at least to ensure that they are placed away from the desire lines.

- provide signage from Main Street to the public toilets;
- ensure that shops and pubs keep pavement space clear of unnecessary clutter such as advertising boards or goods for sale.

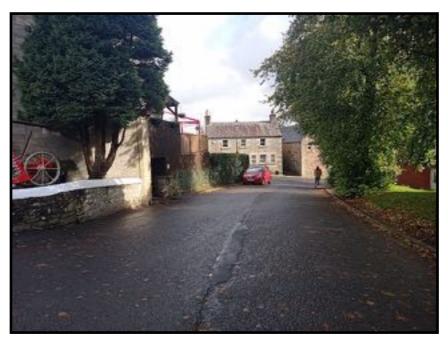
At the north end of Main Street, the B7059 splits into two, providing access to the A702 in both west and east directions. The western spur has no pavement and traffic was encountered accelerating from the village centre (picture 15). The possibility of providing a pavement should be explored. Consideration of traffic calming features and tightening the geometry of the junction splays would also be useful.

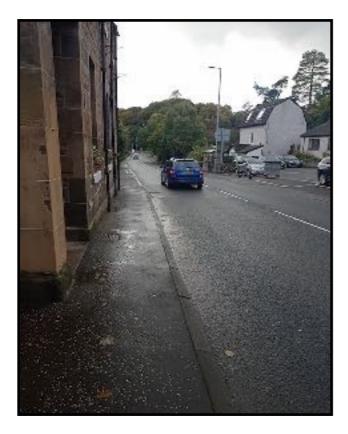
16. PAVEMENT AT GORDON ARMS

The pavement adjacent to the Gordon Arms (picture 16) is very narrow for a walking space next to a busy road with lots of heavy traffic although vehicles are now subject to a 20 mph speed limit. While some traffic was seen to observe the speed limit, some did not. There is a good case for a fixed speed camera to be installed on this stretch of the A702 and this should be explored with the Scottish Safety Camera Partnership.

- in association with Transport Scotland, consider opportunities to introduce pedestrian crossings and speed cameras on the A702.

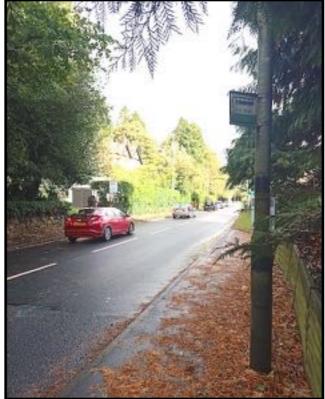
17. A702 BUS STOP

Further north, there is another pair of bus stops (picture 17). On the eastern side of the A702, the pavement does not continue north, requiring pedestrians to cross the road to access a footway, and then to cross again at the roundabout in order to access the main part of West Linton to the east. These bus stops and the roundabout are other locations where new pedestrian crossing facilities would be very useful.

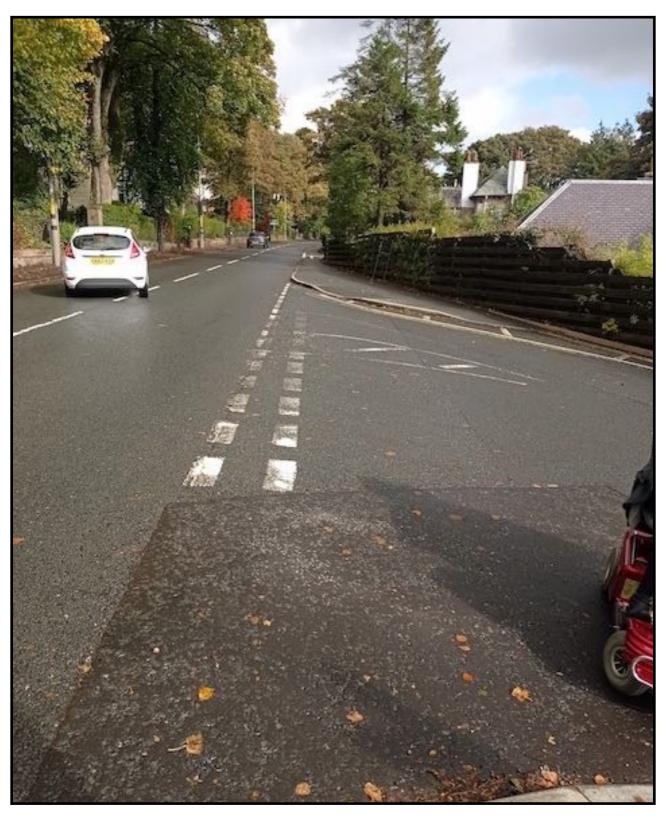
18. B7059 EASTERN SPUR

On the eastern side of the A702, the eastern spur of the B7059 is wide, which encourages fast moving traffic, and would benefit from tightening (picture 18).
