# **Peebles Street Access Audit (1): Central Peebles**

## **Tweeddale Access Panel**

**November 2020**

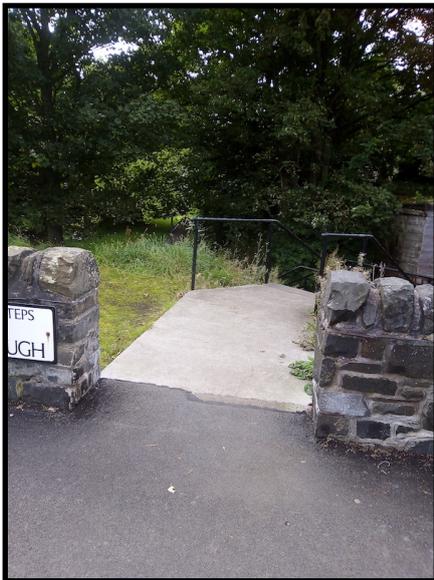
1. GYTES STEPS

The steps from the Leisure Centre to the main road are muddy and slippery. The handrails aren't continuous at the top and would be better if continued to the wall (picture 1).

- clean up steps and extend handrail at Gytes access;
- tidying up of 'A-boards' to encourage shops to keep all adjacent to the building line;
- install tactile paving on western pavement of Northgate at junction with High Street;
- re-paint Blue Badge spaces at Hay Lodge Health Centre;
- protect bus stops with no 'stopping' orders.

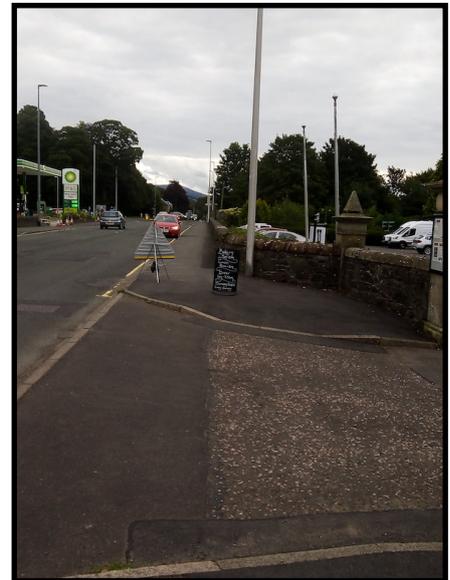
2. 'A-BOARD'

- 1) BT utility works were underway which restricted the pavement to less than 1 metre at one point, and:
- 2) At the entrance to the Park Hotel, a roadworks sign and an advertising board ("A-board") was in the centre of the pavement in the walking desire line. This would be better placed close to the wall (picture 2)

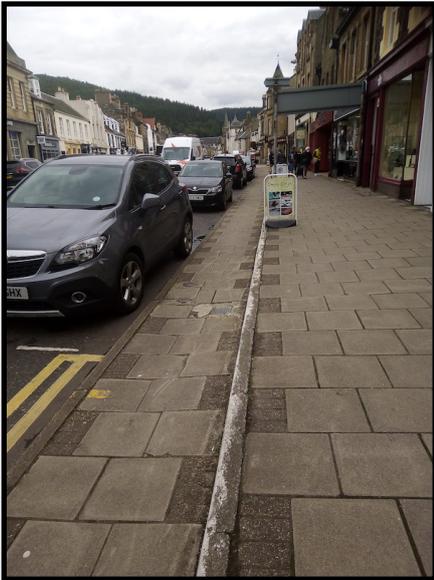
**3. HIGH ST SPLIT PAVEMENT**

At the west end of the High Street, at the corner with the Old Parish Church, the pavement splits into two levels (picture 3). The topography of this corner is complicated, but this feature will be a trip hazard to some people. Possibly tactile paving may be needed to warn visually impaired people of an unexpected step? Further discussion of this feature would be useful.

- investigate the possibility of replacing the roundabout at the Old Parish Church (junction of B7062/A72) with traffic lights, giving protected ('green man') crossing across all three arms;
- at the same location, also consider options for the 'stepped pavement' (picture3);
- install at least two more signalled crossings (e.g. at Old Parish Church, and at eastern end of High Street);
- review parking enforcement strategy - especially with a ban on pavement and double parking coming into effect soon as part of the Transport Act (Scotland) 2019;
- review access to bus stops, especially identifying if more stops need protection from parking (e.g. at the 'town service' stop noted above on the High Street).

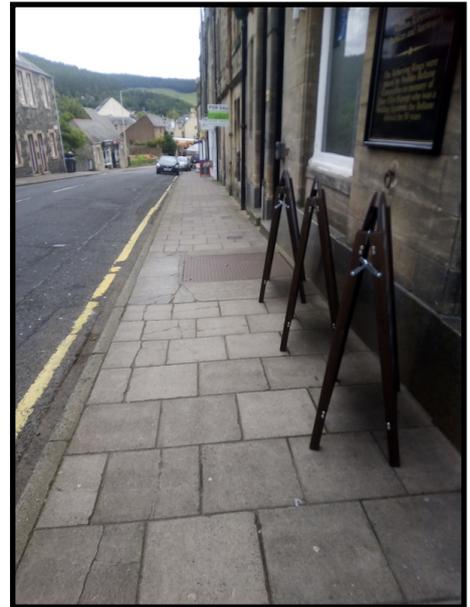
**4. A-BOARDS**

Continuing north and west on the south side of the A72, the streets and pavements are narrower. Consequently, some 'A-boards' become more obstructive for pedestrians (notably at the Neidpath Inn, picture 4). The tactile paving at the Cocoa Black/Castle Warehouse crossing can be slippery when wet.

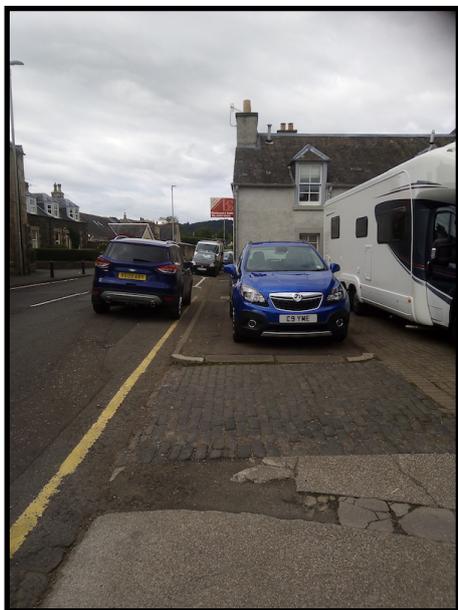
**5. PAVEMENT PARKING**

There was some infringement of the pavement from parked cars; outside JRD Motors, multiple vehicles were parked on the pavement (picture 5). Pavements on Young Street to the north were noted as narrow, with bins causing obstructions. The pavements and road surface on Biggiesknowe were found to be in poor condition.

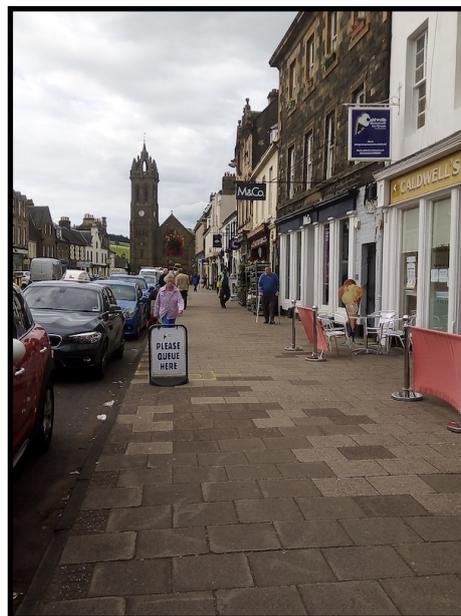
**6. HIGH ST 'CLUTTER'**

Returning to the High Street, pavements were again seen to be in quite good condition and sufficiently wide. There is some 'pavement clutter' through A-boards, cafe tables and chairs, and goods for sale, but generally these are well aligned next to the building line and so don't appear to cause much of an obstruction (picture 6).

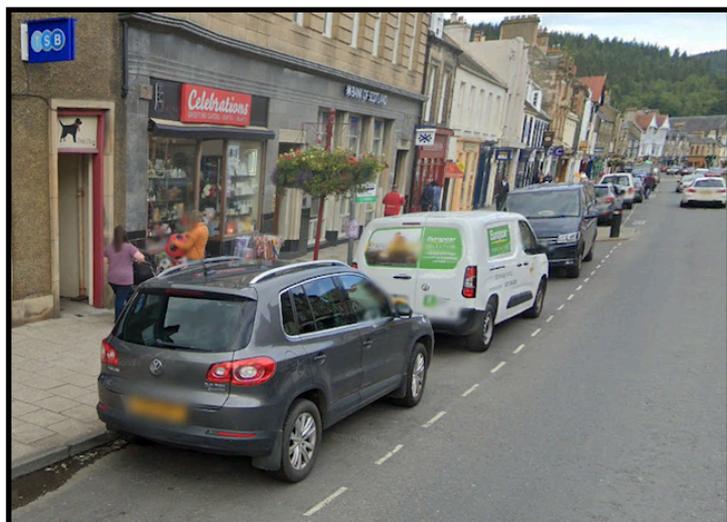
**7. BUS STOP**

There are no facilities (seats, shelter etc) at the 'town service' bus stop near Bank of Scotland. It also does not appear to be protected from parking in any way and was entirely parked on. A 'bus boarder', extending the pavement into the road, should be considered

(picture 7).

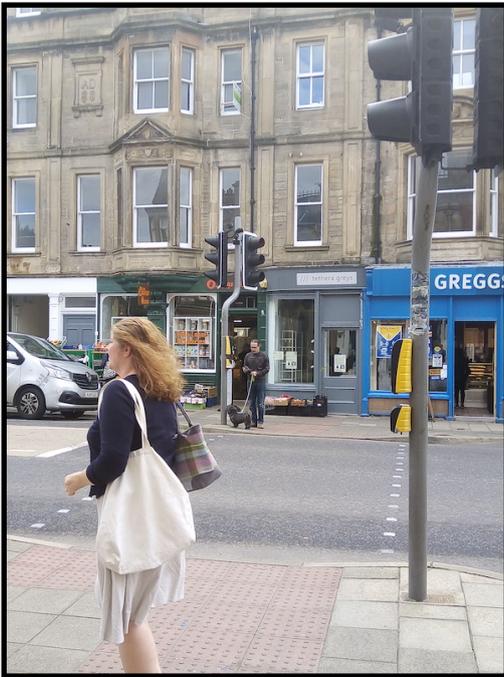
**8. HIGH ST CROSSING**

Although there are two uncontrolled crossings on the western section of the High Street, the pedestrian crossing between Greggs and the Gift Box (picture 8) is the only signalled crossing on the whole of the A72 in Peebles town centre. This is therefore the only safe place that a blind person can cross the High Street with confidence. The junction with Northgate has tactile paving on only the east side; this should be matched with similar on the western pavement (picture 9).
