Broughton Street Access Audit

Tweeddale Access Panel

November 2022

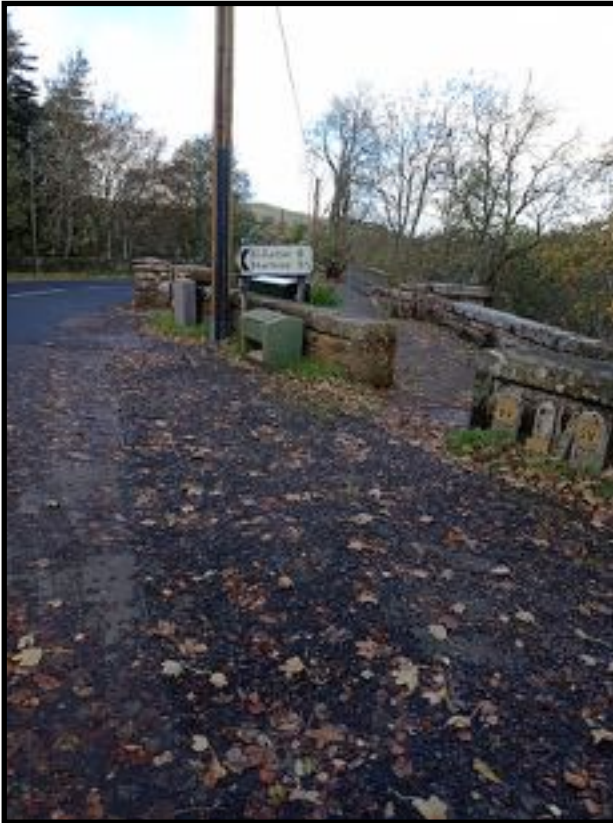
1. APPROACH TO BROUGHTON

At the southern approach to the village, there is a small garden area on the eastern side above the old railway line (picture 1). Access to the pavement is a little rough. The pavement from here to the primary school is less than a metre wide and pedestrians are very close to traffic which generally appeared to be travelling significantly faster than the 20mph limit. If possible, this footway should be widened.

There were no major accessibility issues identified in the audit. It would be useful to widen pavements, especially at the south end of the village and to ensure that there is an opportunity for step-free access from one side of the main road to the other at the bus stops. Some sections of footway have fairly significant trip hazards which should be addressed (see above).

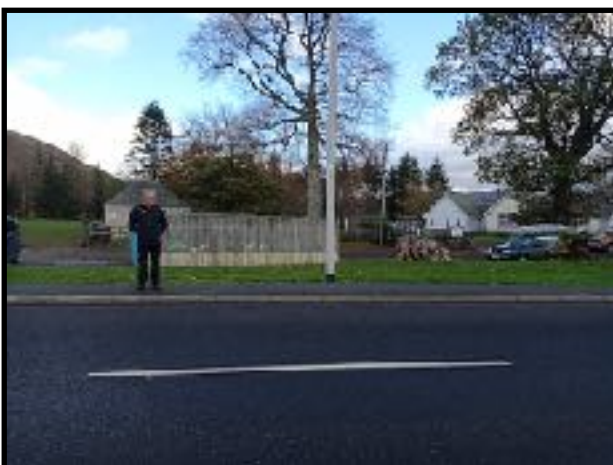
2. BUS STOP

A dropped kerb would be useful between the bus stops opposite the school to provide wheelchair users and others who need level access with a step-free route (picture 2)

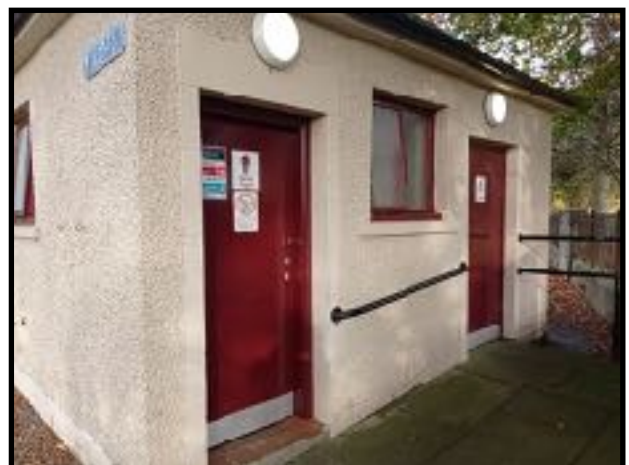
3. TOILETS

There is a public toilet which was open on our visit alongside a disabled toilet requiring RADAR key (picture 3)

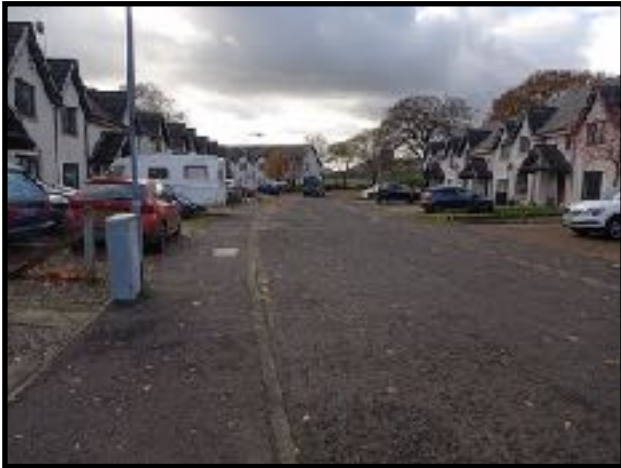
4. HAWDENE

The residential streets of Hawdene, Woodilee and Smithy Croft do not appear to present any significant access difficulties. The lack of definition between carriageway and pavement on Hawdene (picture 4) may be problematic for some blind people in finding their way, but there is a very little traffic. Continuing along the A701, there is a pavement on the eastern side of the road in reasonable condition, apart from one section between Smithy Croft and Dreva Road where (unfinished?) utility works appear to have left the pavement in poor condition (picture 5).

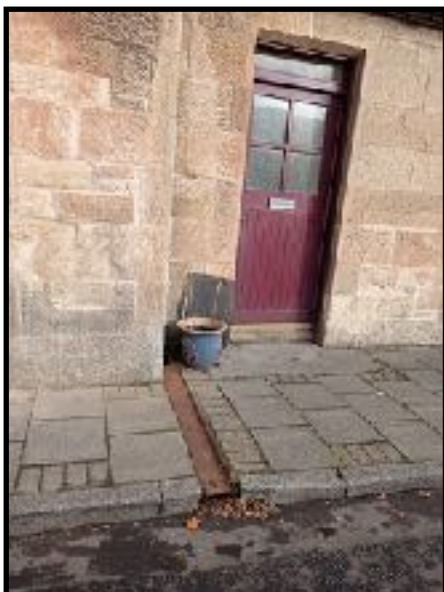
6. DRAIN

Towards the heart of the village to the north, there are some small areas of footway which are defective and should be improved. These include a drain just south of the village hall (picture 6) and the first short stretch of Dreva Road's southern pavement where there is a protruding step at a downpipe and a sunken metal plate (picture 7).

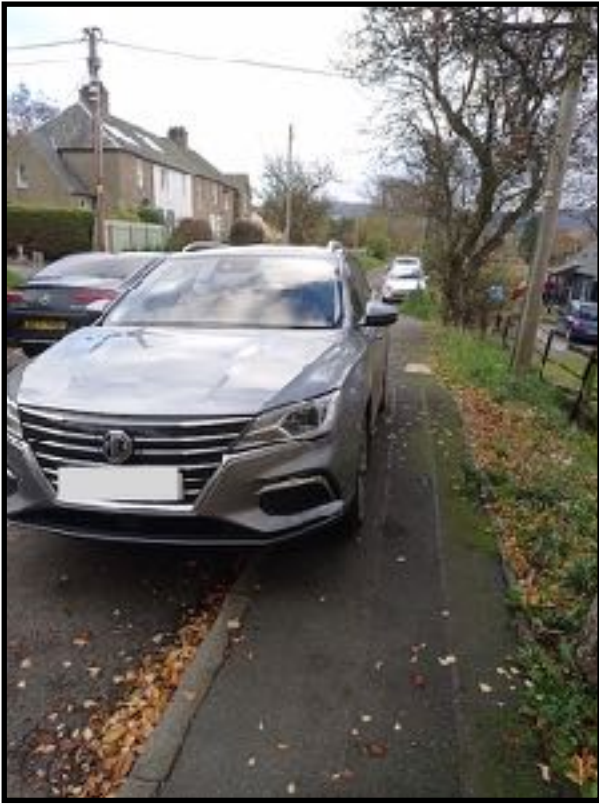
8. PAVEMENT PARKING

Much of the pavement further along Dreva Road is blocked by pavement parking (picture 8). It is not known if this is because wide vehicles such as farm traffic need a lot of space on the carriageway but the effect is to make the pavement unusable. There are some kerbs running across the pavement which would benefit from levelling out (picture 9).

As elsewhere in Borders towns and villages, there is currently no decriminalised parking enforcement in Broughton. Scottish Borders Council should develop a strategy to manage problem parking (such as in the Dreva Road area).

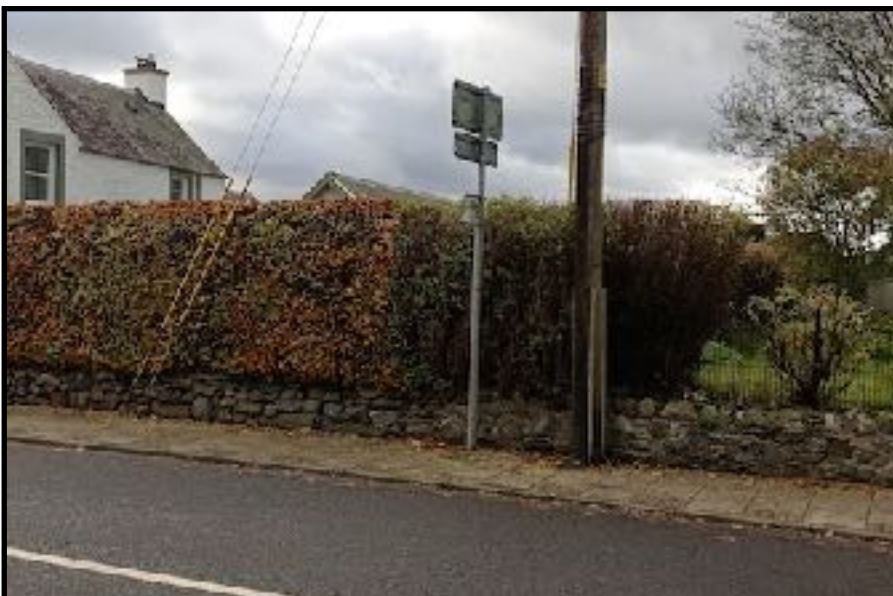
10. BUS STOP

There is another pair of bus stops at this part of the village; again, installing dropped kerbs would be useful to provide a level access route from one side of the road to the other (picture 10).
