Innerleithen Street Access Audit

Tweeddale Access Panel

November 2022

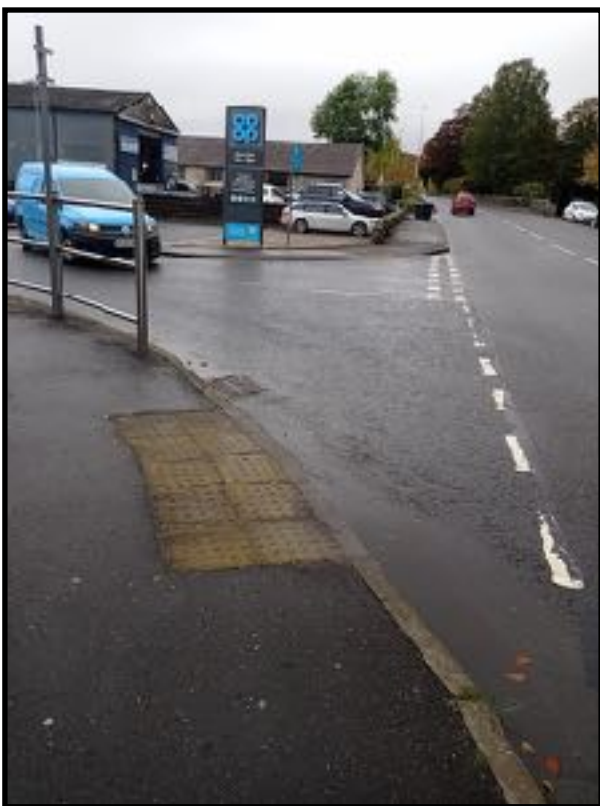
1. CO-OP TACTILES

Following the Peebles Road to the High Street along the southern pavement, the tactile paving at the access roads to both the Peebles Road Garage and the Co-op appears to be incorrectly laid at an angle, directing a blind person following the blister direction into the road (picture 1). The paving should be aligned parallel to the main road. Ideally the junctions could also be 'tightened' to reduce the crossing distance for pedestrians.

- relay tactile pavements at the Peebles Garage and Co-op;
- install tactile paving on south side of the High Street crossing, west of Traquair Road;
- remove the kerb across the footway to the east of Princes Street;
- bus stops should have printed timetables and ideally shelters with seats;
- ensure that shops keep pavement space clear of unnecessary clutter such as advertising boards, bins and bicycles;

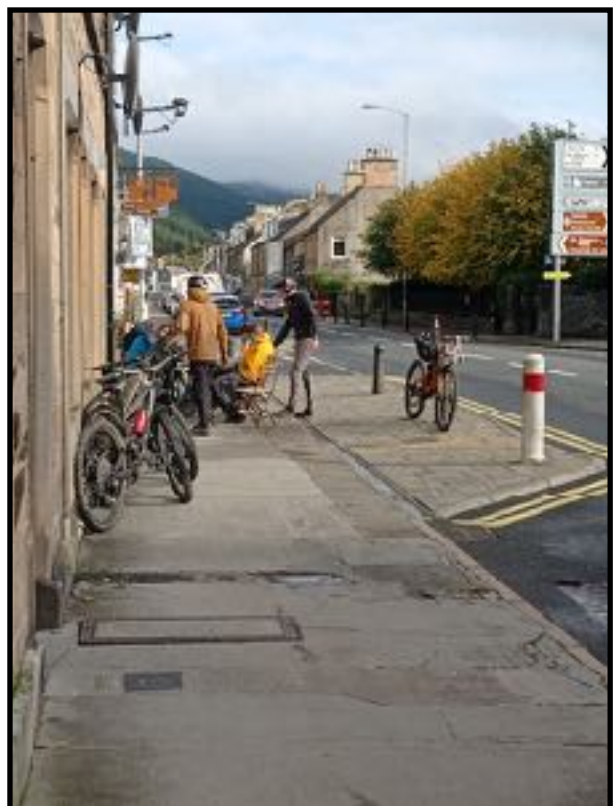
2. PEEBLES ROAD

On the north side of Peebles Road (picture 2) was an example of how the combination of tables, chairs and bike parking presents difficulties to visually impaired pedestrians: this issue is discussed further in the conclusion.

The use of bollards along the High Street was generally welcomed as an effective measure to stop pavement parking. There is some 'pavement clutter' from advertising 'A-Boards', tables and chairs, bins and bike parking which creates difficulty for visually impaired pedestrians. One blind member of TAP commented that such objects, which may move from day to day, were much more of a problem than fixed items like bollards. The audits were carried out on weekdays but it is understood that pavements become much more severely cluttered by bikes especially, at weekends. Another visually impaired person highlighted the problem of poor contrast of obstacles.

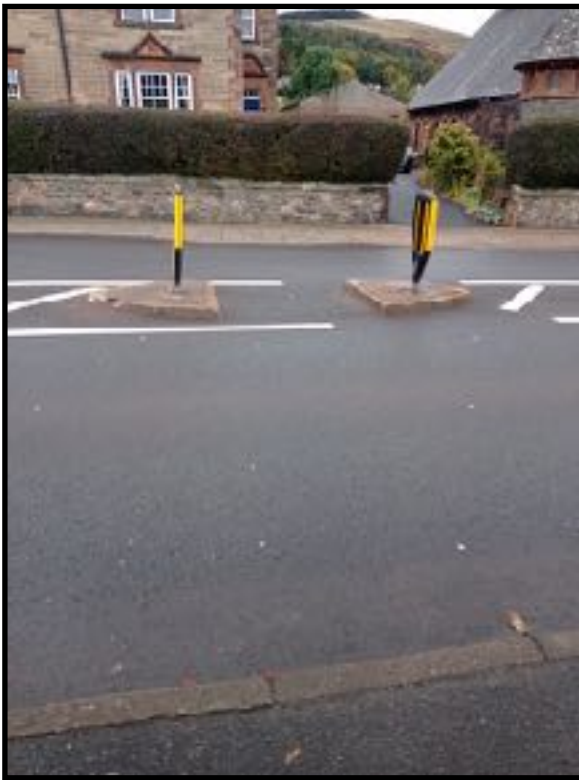
3. CROSSING POINT

The main road (A72) running through Innerleithen has a number of pedestrian crossing opportunities by way of 'double D' islands (picture 3). These were welcomed by audit members in providing confidence to cross the main road. The crossing immediately east of Traquair Road has tactile paving only on the north side - this should also be installed on the south side (picture 4).

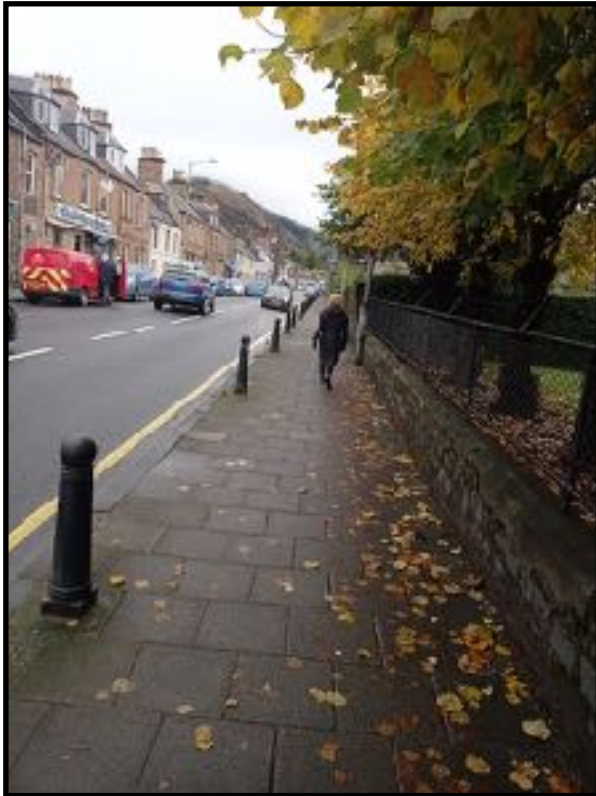
6. HIGH STREET

The pavement on the south side of the High Street is protected by bollards and is of adequate (though not generous) width at around 2 metres and is in good condition (picture 6). A car was observed stopping at and potentially parking on the dropped kerb at 59 High Street (picture 7). As there is no Decriminalised Parking Enforcement (DPE) in the Scottish Borders at present, it would be welcome to see a strategic review parking enforcement arrangements, with a particular focus on effective enforcement of the forthcoming ban on parking on pavements and at dropped kerbs due to be introduced from December 2023.

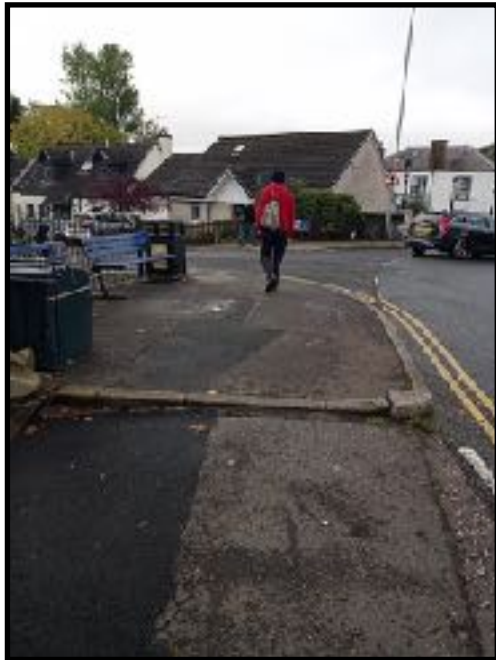
8. KERB ON PAVEMENT

Just east of Princes Street there is a kerb at a private driveway which presents a significant and unnecessary obstacle for pedestrians (picture 8); this should be removed. The easternmost bus stop is in poor condition, dirty with a broken seat and constrained space as a result of the narrow pavement, exacerbated by the round litter bin (picture 9). If there is a possibility of extending the pavement here this would be welcome, as would replacement of the bus shelter.

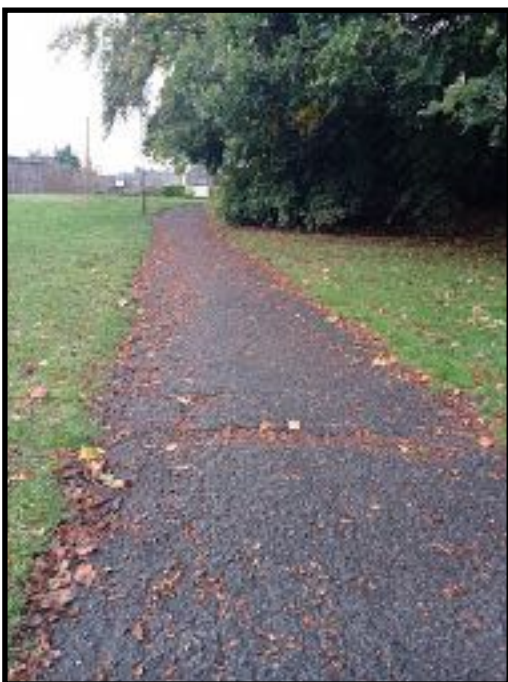
10. PATH TO ST RONAN'S

At this point, our audit route left the main road to follow the path down to the primary school. In places, this was steep and ideally would be levelled out (picture 10). We also recommend some resurfacing as some sections of asphalt are rough and uneven. Approaching the school, there is a small parking area on the north side of the road which causes the footway to divert around the back of these cars. It would be better to provide a continuous direct pavement - or possibly to remove the parking spaces entirely? The carriageway immediately outside the school gates is in fairly poor condition, with road markings barely visible (picture 11). The area would be improved by resurfacing and repainting, including the school crossing 'elephant' markings.

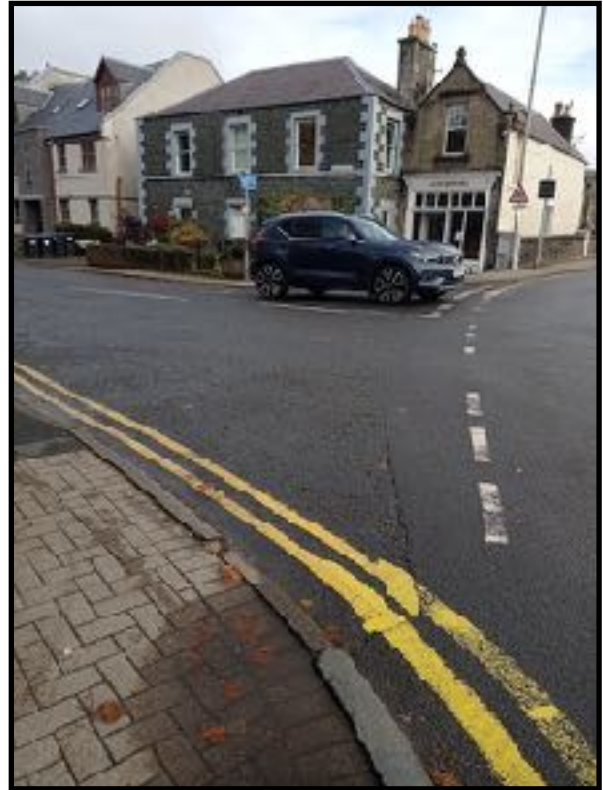
12. LEITHEN ROAD

The junction with Leithen Road has a very wide splay which should be tightened to reduce the distance pedestrians have to cross in the road and also to slow traffic (picture 12). Consideration should be given to installing tactile paving. There is a variable speed indicator immediately to the east of this junction which narrows the pavement: if this is still required (it didn't appear to be in use) it would be better relocated from the narrow pavement (onto the adjacent lighting column?)

- investigate the possibility of improving the most important junctions of the A72, in particular Traquair Road and Leithen Road. The aim would be to shorten the pedestrian crossing distance as much as possible, ensure dropped kerbs are on (or close to) the 'desire lines' and possibly introduce traffic calming measures appropriate to the new 20mph speed limits. It is noted that build-outs have already been installed on some junctions (e.g. Hall Street) which improve them for pedestrians, especially those with mobility difficulties.

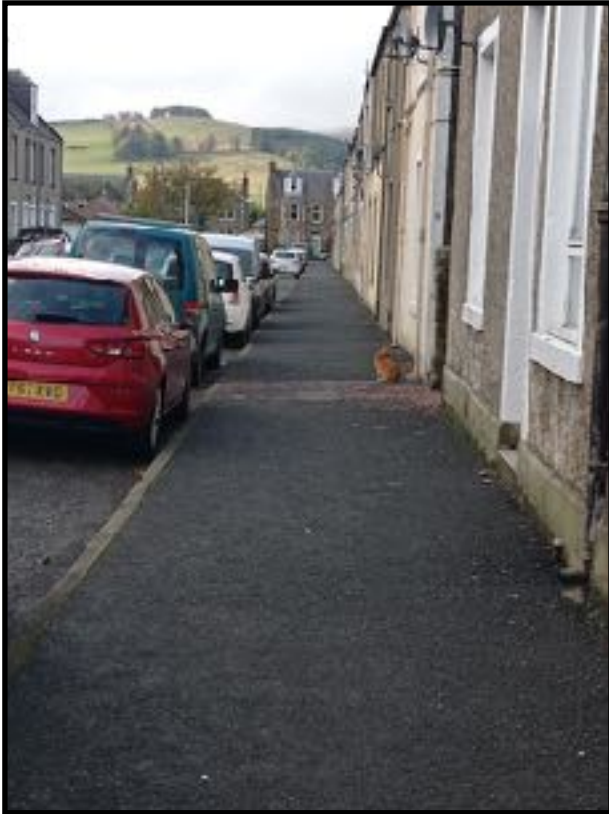
13. MILLER STREET

After crossing to the south side of the town, the pavement on Miller Street was noted to be pleasantly wide and uncluttered (picture 13). At the western end of the street, there is no dropped kerb on the southern side, which forces wheelchair users to travel on the road rather than the pavement.

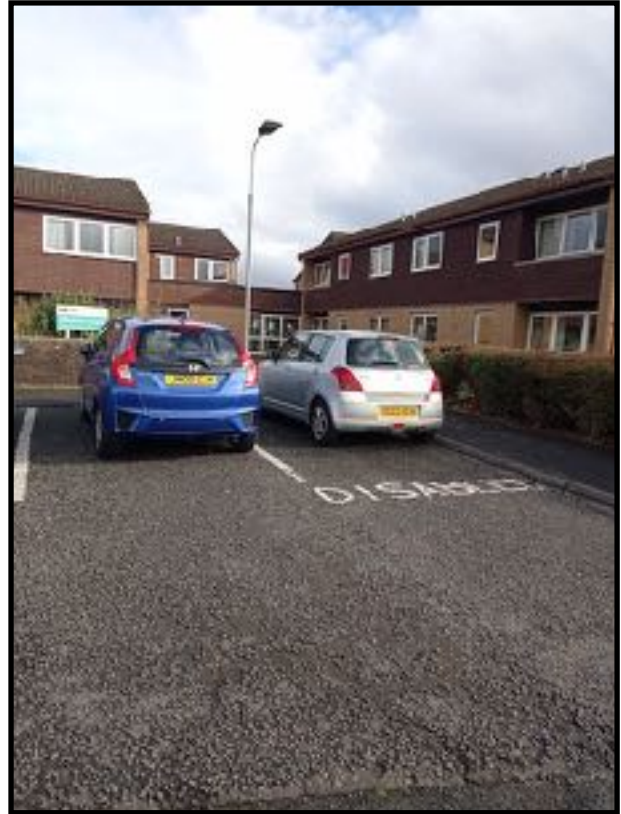
14. BUCHAN PL PARKING

On the approach to the health centre, it was noted that the disabled parking bay in Buchan Place at Hanover Housing Association's supported accommodation is not a full size space and has no level access to the footway (picture 14). A full-sized Blue Badge space would be welcome here, and also at the health centre, where again there is a small 'disabled parking' space and again no access to the footway. Bushes are also encroaching onto the short path to the health centre.

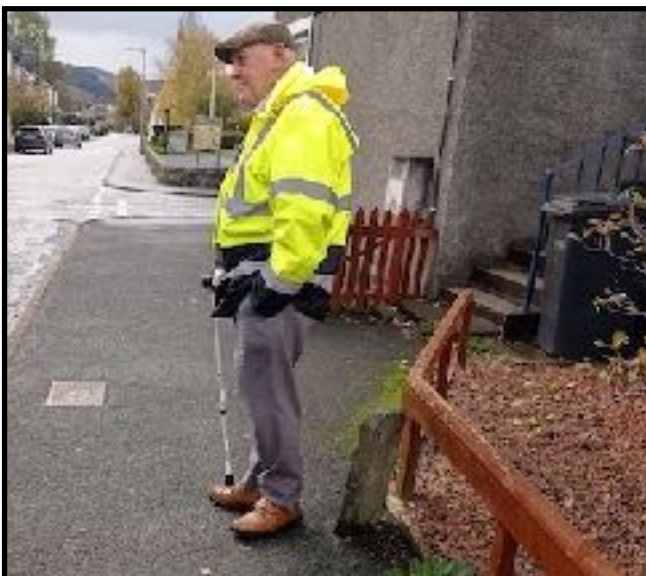
15. HYDRANT SIGN

A second audit covered a loop from the High Street up Leithen Road, the Strand, Maxwell Street, through the parks to Hall Street and returning along the northern High Street pavement. Apart from the High Street/Leithen Road junction itself (see above), the initial route was found to be in quite good condition, with adequate pavement surfaces and dropped kerbs. Some small, hard-to-detect obstacles such as a poorly-sited water hydrant sign at 3 Leithen Road, were identified as a trip hazard (picture 15).

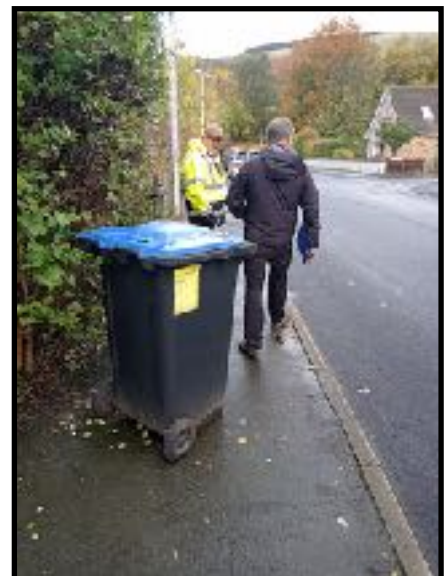
16. BIN

The pavement on the south side of the Strand is in places rough and was partly blocked by bins (picture 16). The kerbs at the junction with Nursery Lane are not level and should be made flush. Undulating 'up-and-down' pavements at driveways were reported to be a problem; ideally at least 1 metre of footway width should be level.

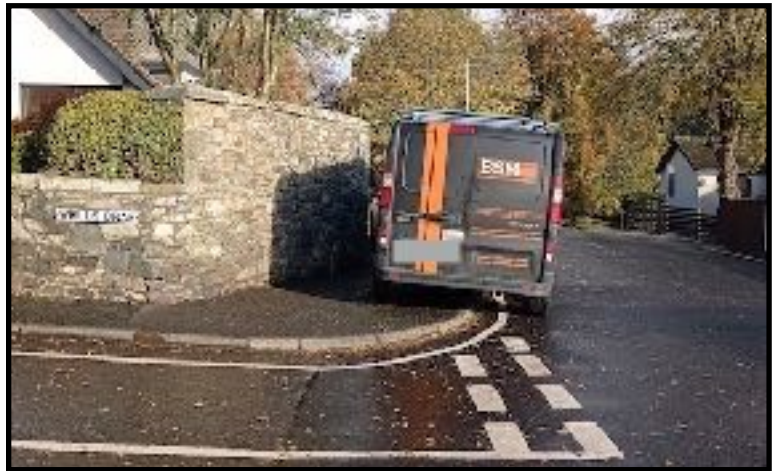
17. VAN ON PAVEMENT

As the road becomes Damside, there is no pavement at all although the carriageway is smooth having been recently resurfaced. A holly hedge at Hill House should be kept cut right back from the pavement - even small encroachment onto the pavement can be very unpleasant for people who cannot see well, and can't usually be detected by a mobility aid such as a long cane or guide dog. At the corner of Maxwell Street, a van was parked on the corner, completely blocking the pavement (picture 17).

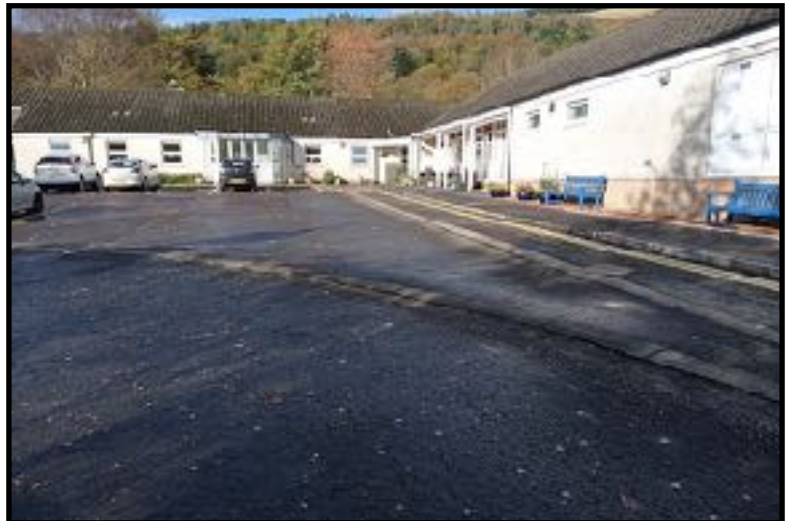
18. ST RONAN'S HOUSE

The entrance area to St Ronan's House Residential Home has a large tarmac space outside, with a number of 'false kerbs' (picture 18) perhaps remnants of an earlier road configuration? This may be confusing to people with dementia, and it is recommended that this is explored with residents and staff.

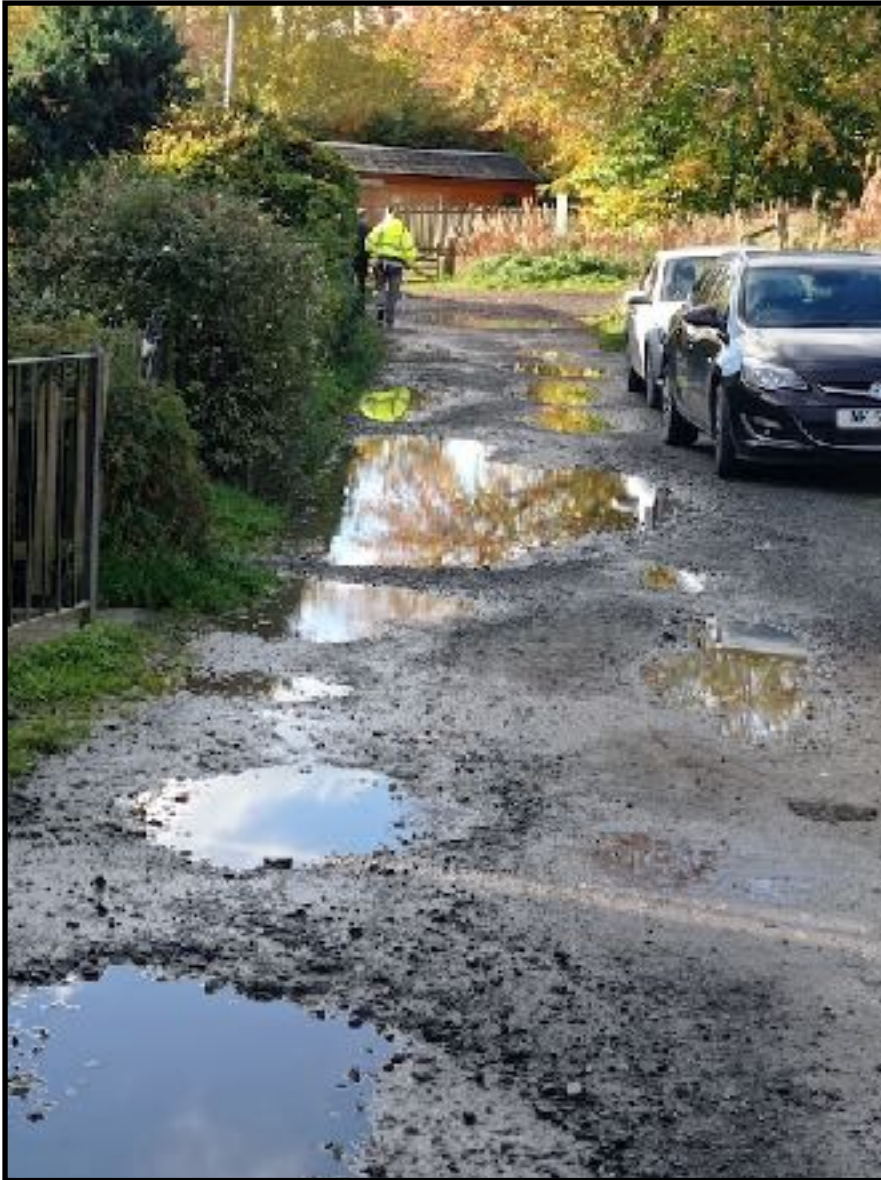
19. POTHOLED ROUTE TO THE PARK

The Route from St Ronan's House to the parks area is initially well surfaced but suddenly becomes full of potholes and puddles, very hostile to any person with a mobility impairment (picture 19). It is unlikely that residents from St Ronan's would be able to reach the park area through this, the obvious, direct route. It is understood that the road is the responsibility of Traquair Estates and it is strongly recommended that they are encouraged to improve the road surface, especially in order to enhance it as a key route from St Ronan's House.

- cut back vegetation where it encroaches on pedestrian space;
- add colour contrasted reflective tape to make obstacles such as telegraph poles, bollards etc. more visible;
- contact Traquair estates to encourage improvement of the path from St Ronan's House to the parks;
- resurface the area outside the Hall Street public toilets.

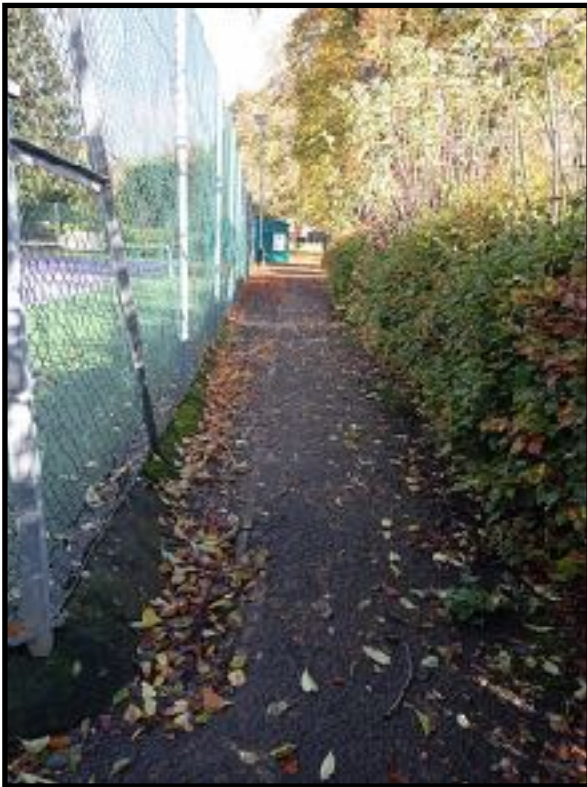
20. HEDGES

Continuing past the tennis courts, cutting back vegetation would again aid access along the path (picture 20). There is a poorly maintained (and very low) seat just past the tennis courts; more availability of seating (and variety - for example including seats with arm rests) in the area, - would be welcome.

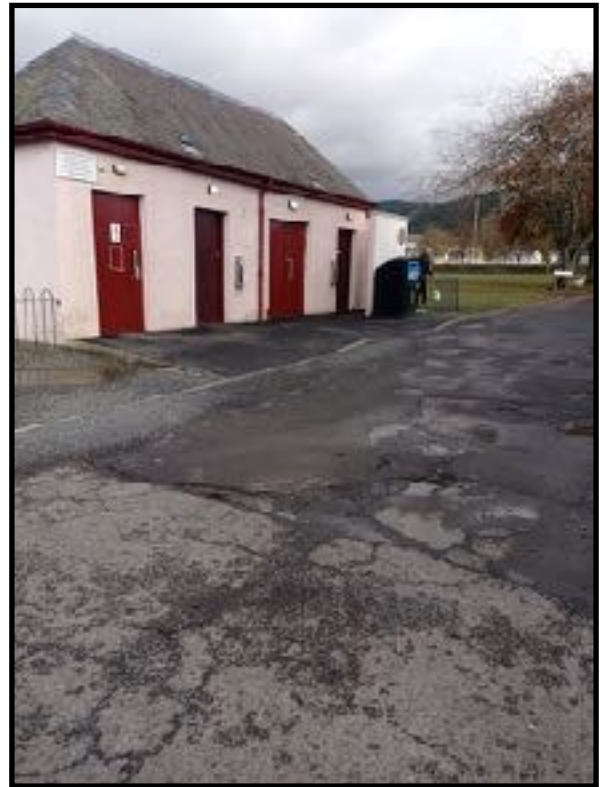
21. TOILETS AND ROUGH SURFACE

After crossing the Hall Street car park, the public toilets are situated on a very rough stretch of road which should be resurfaced (picture 21). The toilets themselves require 30p in coins to use them and we encountered two members of the public trying to access the toilets with some difficulty. While recognising the cost of maintaining council-run toilets, easily-accessible free toilets (as in West Linton) are very important in enhancing the accessibility of an area for many people, especially disabled people (and children. older people, women, etc.)

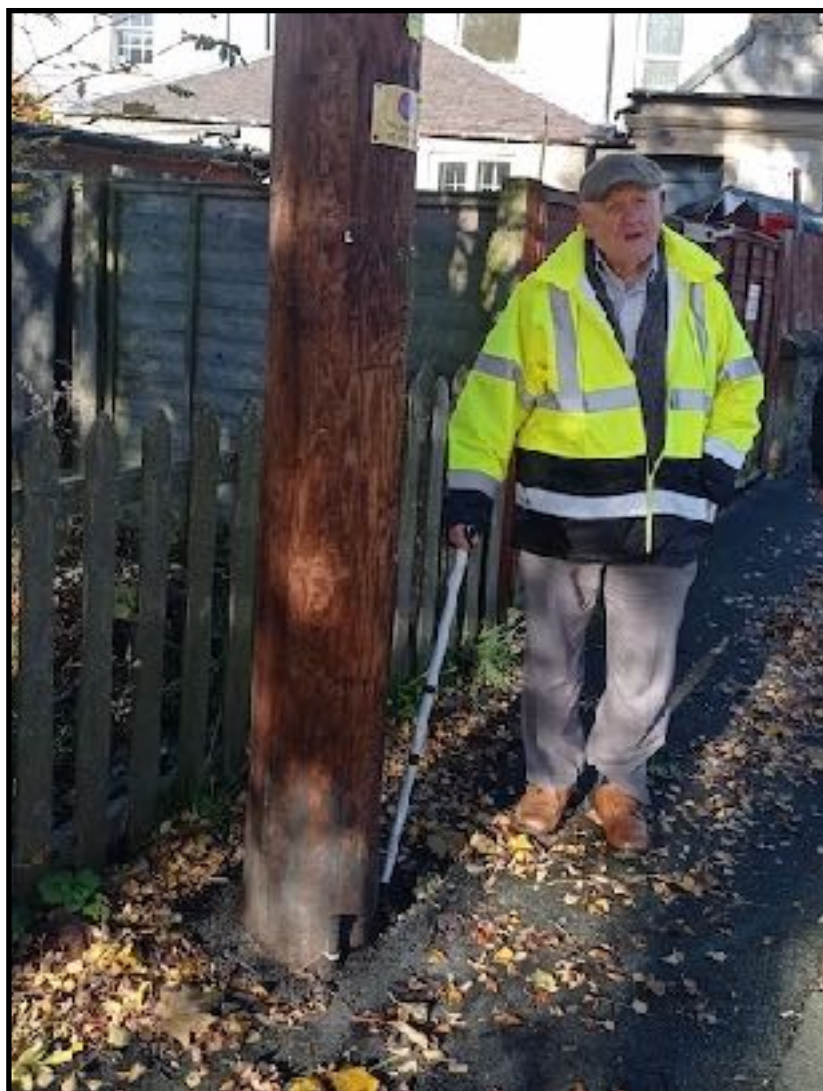
22. TELEGRAPH POLE

South of the High Street, on the west side of Leithen Crescent, a telegraph pole was identified as a particular hazard, lacking visual contrast (picture 22). Adding high visibility tape to this, and other fixed obstacles, would help visually impaired pedestrians to avoid such obstructions.
