Walkerburn Street Access Audit

Tweeddale Access Panel

November 2022

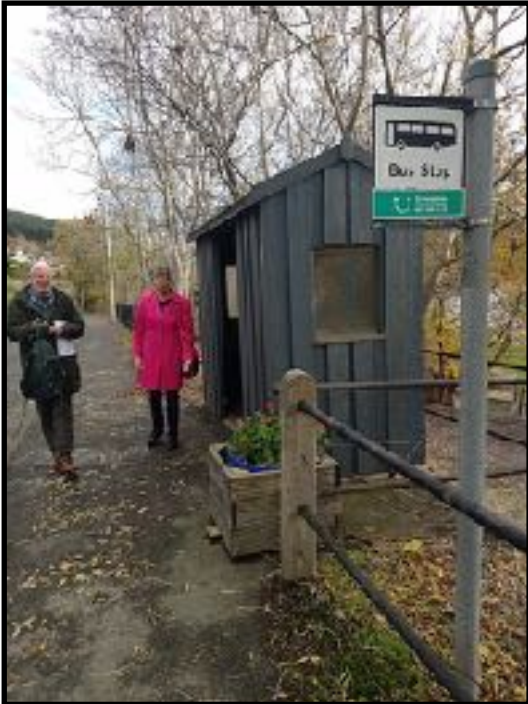
1. BUS SHELTER

The westernmost bus stop on the south side of the A72 has flowers planted beside it, but the shelter is in very poor condition: dirty with, no seat or timetable information (picture 1). The pavement suffers from overhanging branches and other vegetation (picture 2) which needs to be cut back regularly. This is a particular hazard for visually impaired people.

- cut back vegetation on the A72;
- repair the seat on the A72 (picture 3 above) and replace the seat at the Post Office;
- ask Borders Buses to post up to date timetable information at bus stops;
- 'drop' the kerb on Caberston Road approaching the primary school.

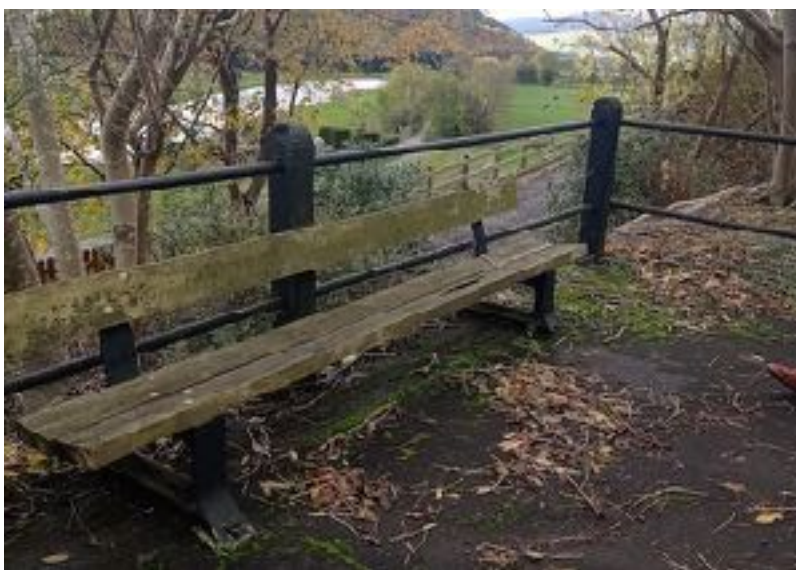
3. BENCH

There is a very dilapidated (and low) bench which could be repaired, including adding arm rests (picture 3).

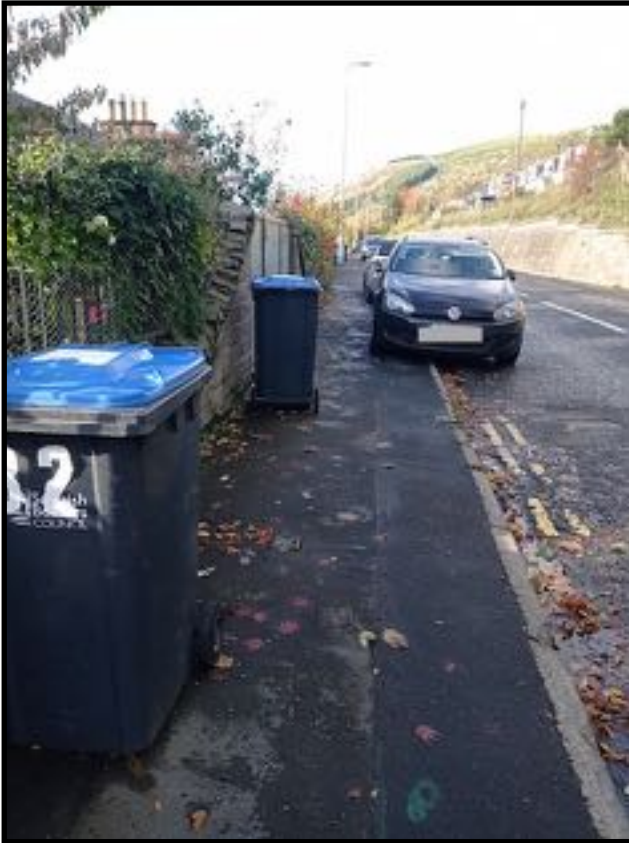
4. PAVEMENT PARKING AND BINS

The chief problem with the pavement here is that it is severely obstructed by both pavement parking and bins (picture 4). In places, the gap for pedestrians was only 70cm. Many disabled people, including wheelchair users, would be unable to navigate the pavement and the carriageway is not safe for walking or wheeling.

recommended that Scottish Borders Councils prepares a 'parking strategy' for the village, in conjunction with local residents and organisations such as the community council.

It is recognised that finding solutions to the parking problem in the village will be challenging, but options to explore include introducing a permit system to limit on-street parking, and relocating parking to other parts of the village (such as Park Avenue?) where there appears to be spare carriageway space.

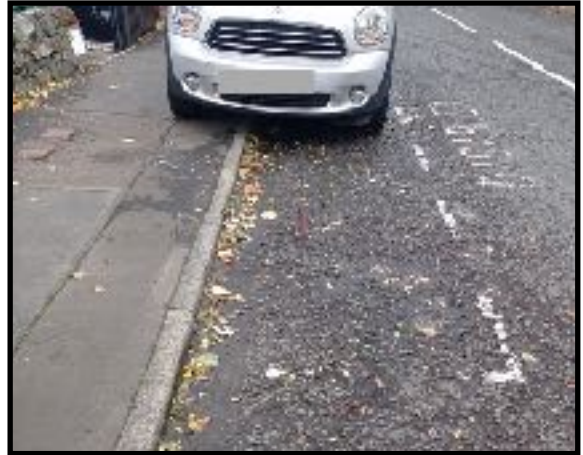
5. TOO-NARROW DISABLED PARKING BAY

There are some 'disabled parking' spaces marked on the road which are so narrow that it is not possible to park a normal sized car in them (picture 5); this effectively appears to encourage pavement parking.

The western pavement on the south side of the A72 is difficult or impossible for disabled people to use owing to the proliferation of pavement parking. The extremely narrow disabled parking bays marked out by SBC suggests that pavement parking is effectively condoned by the Council in this location in order to aid traffic flow. The problem, of course, is made worse by additional obstructions on bin collection day, which coincided with our visit.

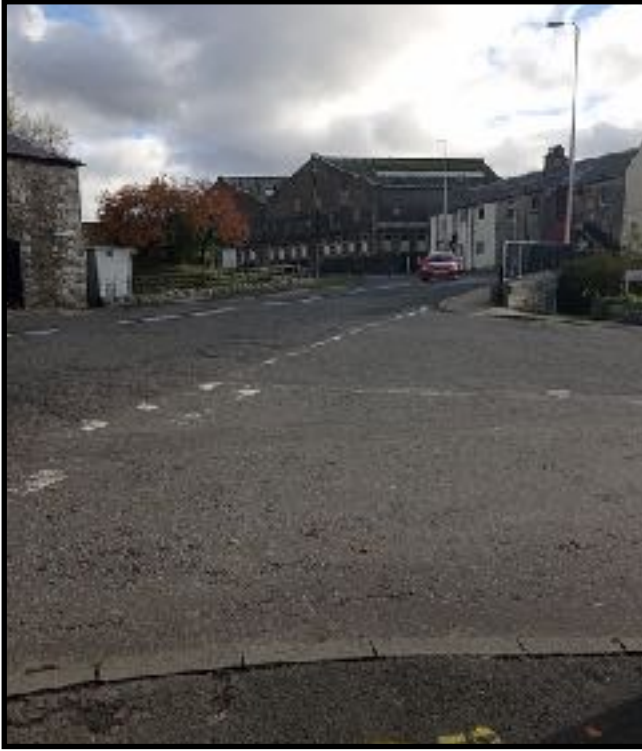
6. CABERSTON ROAD JUNCTION

The junction with Caberston Road has a wide splay with poor dropped kerbs (picture 6). It is understood that the road is used by many heavy vehicles which may limit the opportunity to 'tighten' the junction.

- Consider if the junctions of the A72 with Caberston Road and Hall Street can be improved;
- investigate the possibility of addressing the lack of crossing opportunities on A72 including step-free crossings at each pair of bus stops;
- develop a parking strategy for the village focussed on addressing the problems of pavement parking.

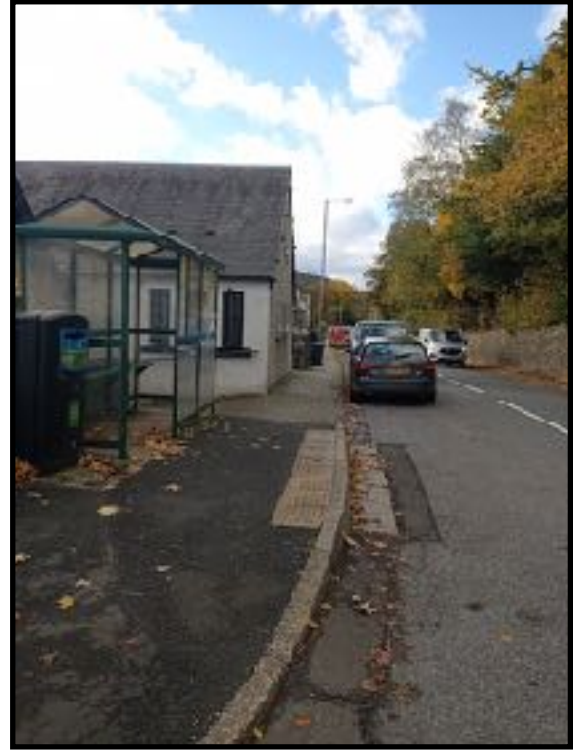
7. BUS STOP

At the village hall, a car was seen parked close to the bus stop which could impede buses accessing the kerb (picture 7). Some protection of this (and other?) bus stops such as yellow lines might be considered. There is no information at bus stops other than in some cases, a QR code: this will not meet all passengers' access needs and would be better replaced by printed timetables.

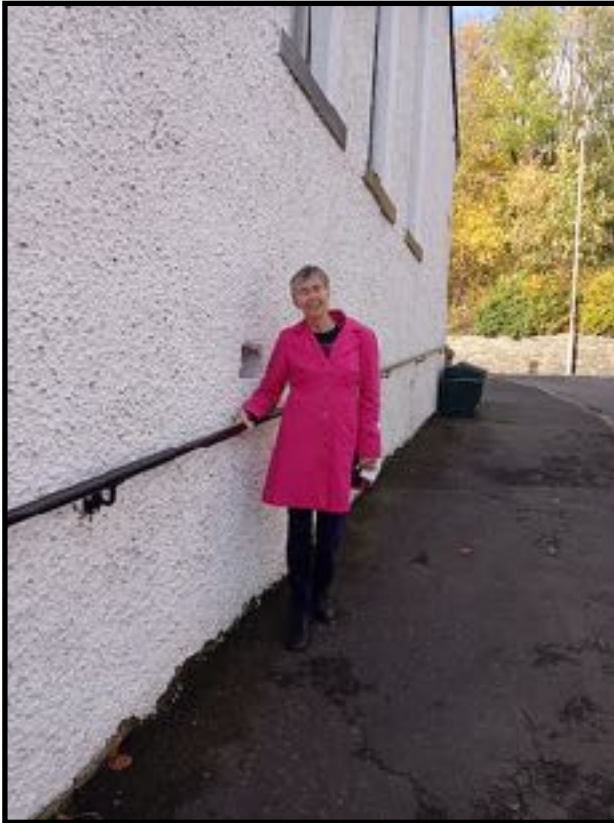
8. RAILING

Leaving the main road southward down Hall Street, there is a hand rail along the western pavement, which was reported to be welcome (picture 8). The steep south-facing incline of the village presents fundamental accessibility challenges. An unnecessary 20mph sign and pole at the top of Hall Street Brae (east side) could be removed (assuming 20mph is to stay in place for the whole village). The junction would be improved by reducing the radius of the western part of the junction splay to make it 'tighter' (picture 9).

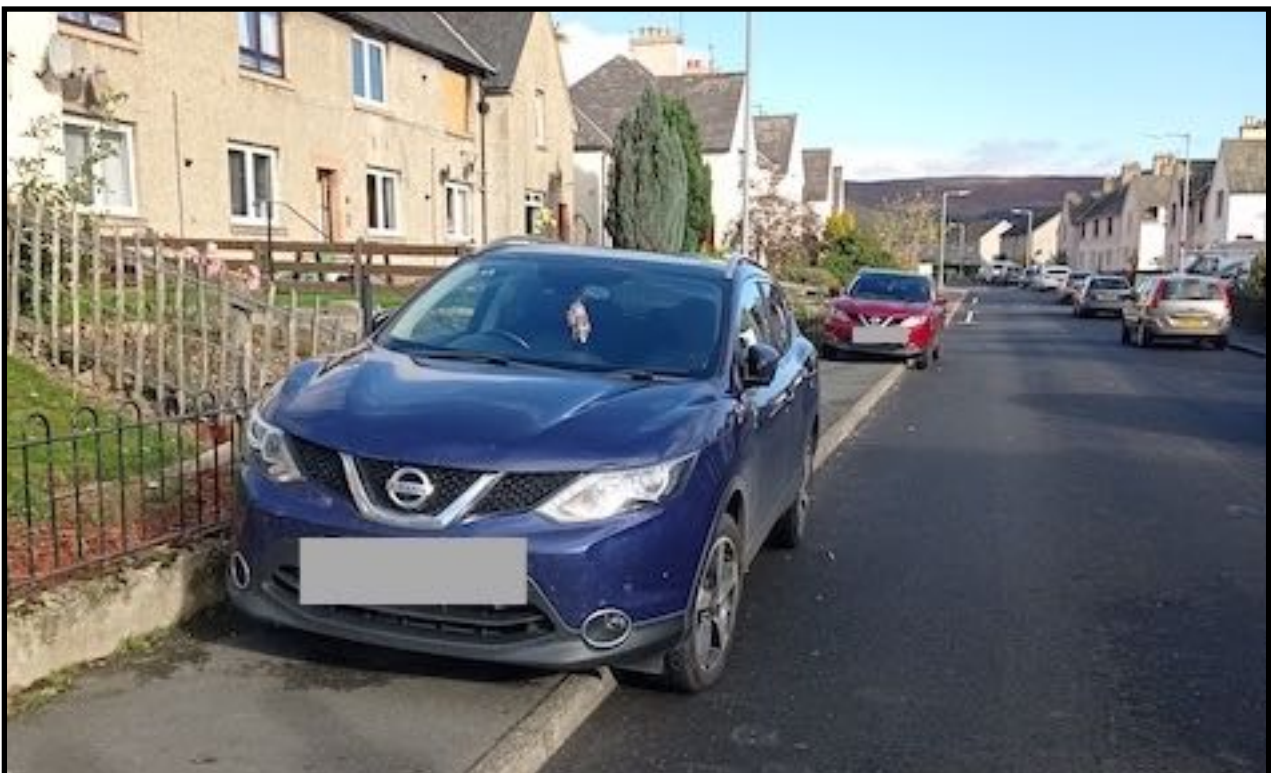
10. PAVEMENT PARKING

In Tweedholm Avenue East, on what was probably a fairly quiet Friday afternoon, we saw seven cars parked on the pavement on the north side very close to garden walls or fences, to allow room for traffic to get past (picture 10). This made the pavement completely unusable by any pedestrians.

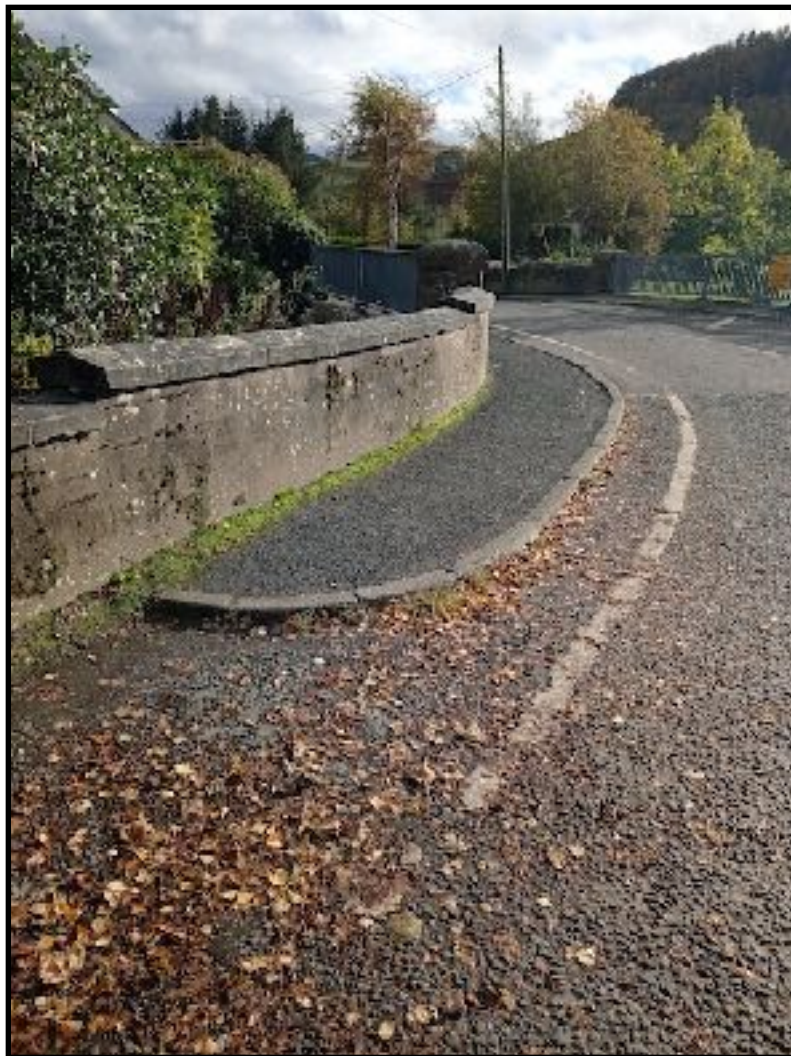
11. CABERSTON ROAD AT SCHOOL

The pavement approaching the primary school on the north side of Caberston Road ends with a kerb: this should be 'dropped', permitting level access to cross the road to the school (picture 11).
